DOCUMENT NO. T5-6539-99

TITLE METALLURGICAL ANALYSIS OF BACB30GZ8 FASTENER FAILURES.

504 VEHICLE FUEL TANK

MODEL NO. Saturn V/S-10 CONTRACT NO. NAS 8-5608

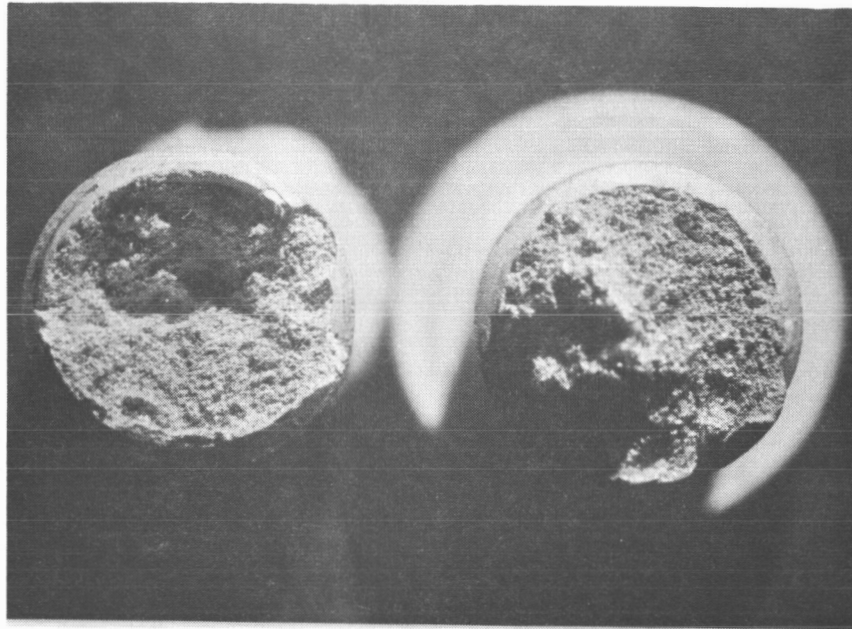
FIGURE 2 - FRACTURE SURFACES, SPECIMEN 1, 8X

It is concluded that seven BACB30GZ8 fasteners from the 504 vehicle fuel tank failed by stress corrosion cracking which initiated at areas of recrystallization.

Fractographic study at 7X to 30X using a wide field stereoscope revealed fracture surfaces typical of stress corrosion cracking in fasteners of this type. Figures 2 - 7 are fractographs of each specimen showing a distended surface characteristic of the expansion associated with corrosion in aluminum alloys. Microscopic study of metallographic specimens at 100X and 500X revealed all fractures to be intergranular, with secondary intergranular cracking. This type of fracture mode and crack pattern is typical of stress corrosion cracking in 7075-T6 aluminum alloy. Figures 8 - 13 show the results of microscopic examination. It was noted in specimen number four, shown in figure eleven that although failure was in the head to shank transition stress corrosion cracking was also observed in the thread region.

It is recommended that these fasteners be manufactured as stated in T5-6539-93, i.e., to remove the unfavorable recrystallized grain in the threads and in the head. This can be accomplished by doing all forming after solution heat treatment. An alternate solution would be the use of BACC30PR collars which induce lower preloads.

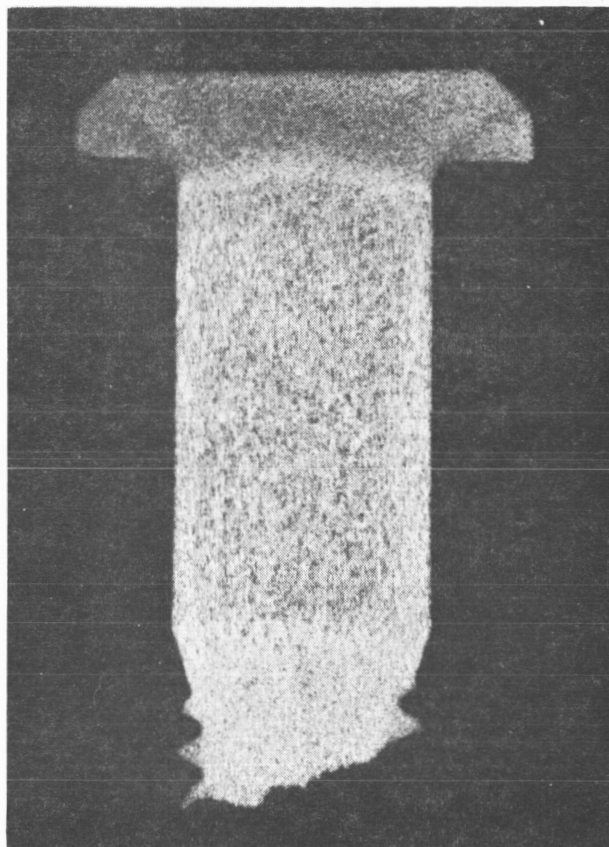
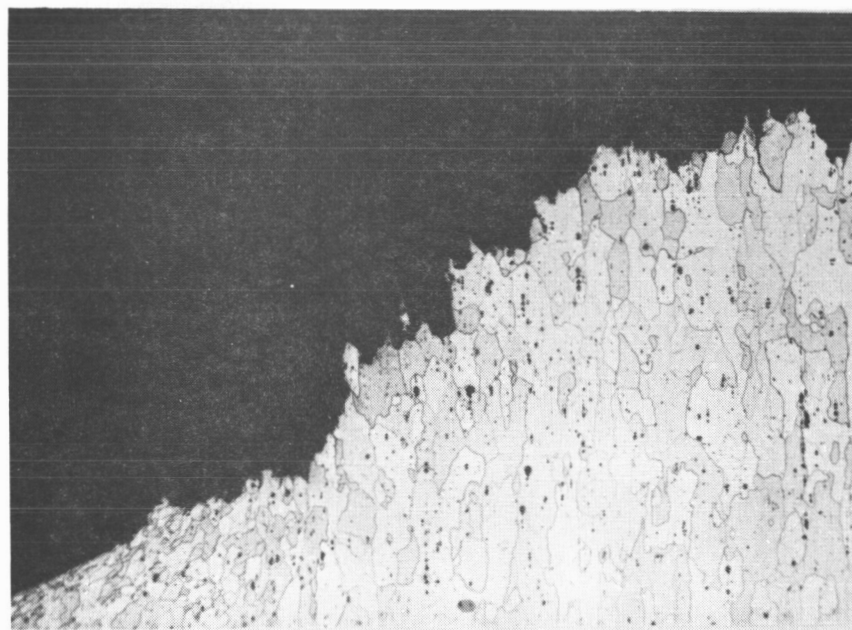
FIGURE 8 - MICROSTRUCTURE, SPECIMEN 1

5.3 Stress corrosion is produced by the interaction of sustained tensile stress and a corrosion reaction. In all cases failure and cracking occurred at regions where manufacturing had produced a recrystallized grain structure and where there was a stress concentration. The raising of the stress corrosion threshold by the elimination of recrystallized grain structure or the reduction of stress concentrations, by the lowering of preload, will reduce the possibility of failure.
